AIAA 99-2706

An Overview of the On-Orbit Results from the ESEX Flight Experiment

**35th AIAA/ASME/SAE/ASEE Joint Propulsion
Conference and Exhibit
20-24 June 1999
Los Angeles, California**

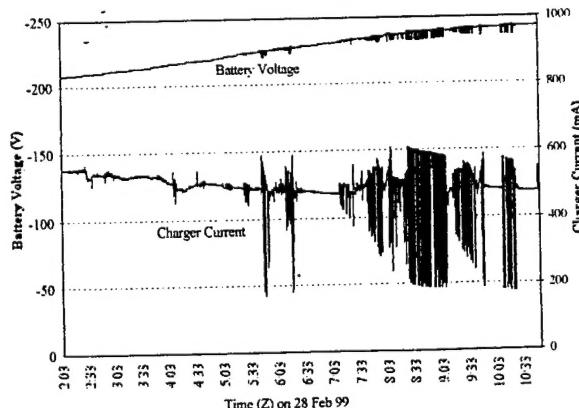
Battery Anomaly - The first signs of anomalous behavior in the battery were observed during the first charging cycle, shortly following the first ARGOS sunsafe. The charging circuit operated nominally (except for a low output current) until the battery voltage approached -225 Vdc. At this point, as shown in Figure 6, the output current from the charging circuit began cycling on and off, resulting in oscillations of the open circuit battery voltage. Initially, this was thought to be a result of a higher-than-expected internal battery

resistance. In an attempt to lower the circuit impedance, high inductance filters were switched into the circuit via the high voltage relays connecting the battery with the PCU.^{7,8} This did improve the stability somewhat, but did not eliminate the fluctuations. Since this instability was not detrimental to the ESEX battery or the spacecraft bus, it was decided to charge through this region and realize the charging inefficiencies by extending the charging time. Subsequent charge cycles showed a degrading instability that caused the charging circuit to shut off prior to attaining a full state of charge in the battery. Further analyses seem to indicate these charging instabilities were indicative of the ultimate problem, which appears to be related to the mechanical properties of the interconnections between the battery cells.

Beginning on firing #4, further anomalous behavior on the battery output started appearing which resulted in a limited total firing duration. The manifestation of this anomaly was low battery output voltage, resulting in an unstable PCU and arcjet operation - eventually extinguishing the arc. As can be seen in Table 1, the duration of each firing after #4 steadily decreased, as the battery performance deteriorated. Ultimately, on firing #7, the arcjet cycled on and off twice (due to the command logic in the PCU) - both firings being extremely short. After this event, the battery was reconditioned by performing a deep discharge through the bleed resistors, and restarting the battery charge. The initial plan was to wait until the battery was at a full state of charge (indicated by the charger circuit shutting off at the upper charge limit) before attempting the next firing. After approximately 19 days, however, the battery charger was commanded off and a firing was attempted. Unfortunately, as can be seen by the short duration of firing #8, the reconditioning was unsuccessful in resolving the problem.

Figure 6 - Typical battery charging circuit instability

The cause of the battery problem appears to be related to the mechanical interconnections between the cells. Although the analyses are not complete, preliminary results indicate the construction of the interconnections allowed the contact resistance to the cell to fluctuate and deteriorate over time (mostly as a function of temperature). This deteriorating contact resistance led to localized heating at the cell during any charge or discharge cycle, but would be greatly enhanced during

the high current discharge associated with the arcjet firings. Eventually the heating would be enough to rupture the cell, causing electrolyte leakage, and the short circuit to the battery case. This scenario has not been proven explicitly, but it does account for all of the data observed including the charging circuit instabilities, the decreasing capability to support arcjet firings, and the ultimate failure of the battery.

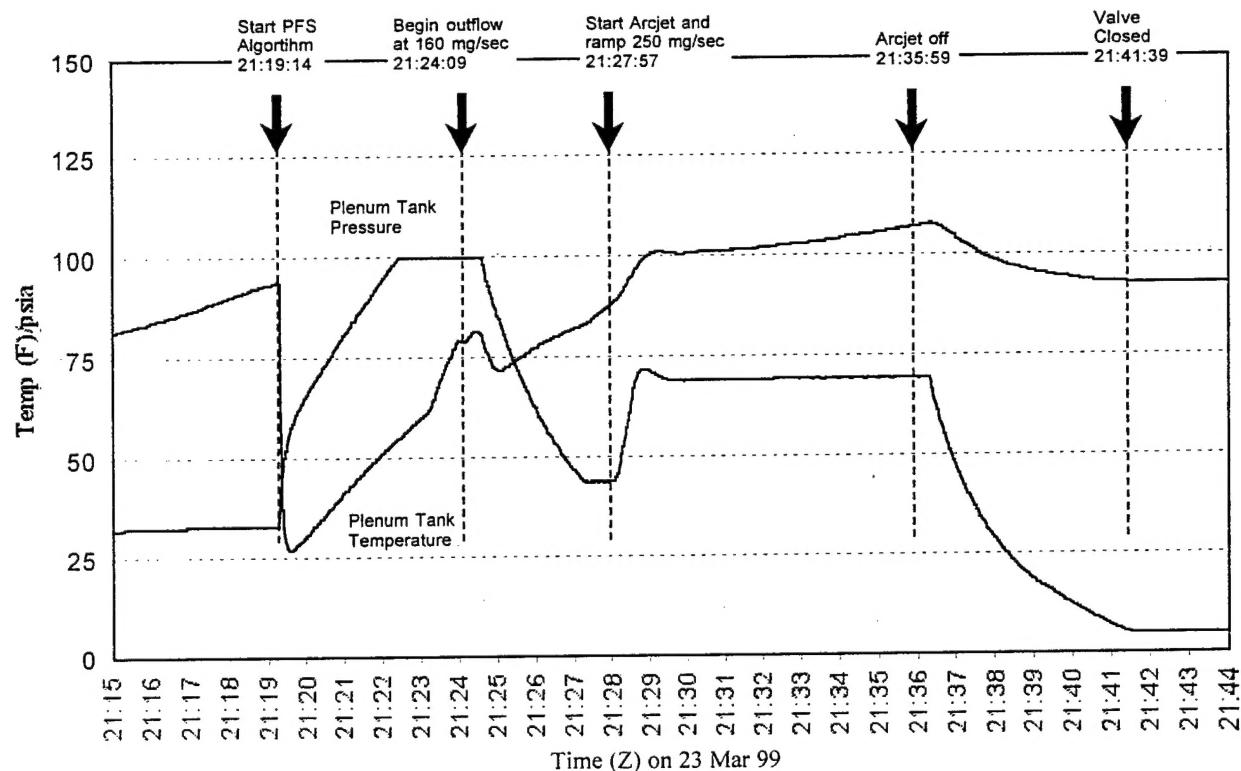
Figure 7 - Typical PFS performance showing liquid ingestion into the plenum tank

PFS Liquid Ingestion - The liquid ingestion was initially observed on the first successful NH₃ outflow (see Table 1). Figure 7 illustrates a typical outflow, where the temperature in the plenum tank drops dramatically (between 30-100°F) as soon as the PFS flow control algorithm is initiated.

The problem appears to be a cold spot in the propellant line somewhere between the enhanced feedline heater (EFH) and the DPC valve. This cold spot allows NH₃ to condense and collect just upstream of the DPC valve. The liquid ingestion seems to occur only at the initiation of the PFS algorithm, which causes a single cycle of the DPC valve regardless of the plenum tank pressure. This valve cycle releases this slug of liquefied NH₃ into the plenum tank - which is at a relatively low pressure - resulting in a dramatic expansion and evaporation of the liquid. As can be seen in Figure 7, this expansion cools the plenum tank dramatically resulting in a saturated liquid in the tank. As the plenum tank heater vaporizes the ingested liquid,

The root cause of the problem - the cold spot in the system - was possibly a result of a cooler mounting platform than experienced during test. This platform temperature is not actively controlled, and can drift significantly - perhaps leading to a low enough temperature to condense NH₃ at the pressure in the propellant line.

To further support this possibility, there were some variations from the normal procedure on the last firing (F-8) and no liquid ingestion was observed. For that case, the PFS heaters were turned on many hours before the actual firing attempt as a result of waiting for the battery reconditioning to complete. This may suggest the cold spot in the propellant line had enough time to heat up and vaporize the condensed NH₃.

In summary, the liquid ingestion proved to be an annoyance, but did not seriously detract from the arcjet operation. Other than this issue, the PFS performed exceptionally well. The flow rate control generally operated to within ± 0.3 mg/sec at steady-state conditions - much better than the design requirement of ± 5 mg/sec. If this system evolves into an operational flight design, some heater power applied to the section of the propellant line in question could almost assuredly resolve the issue entirely - especially in light of the results from the last firing.

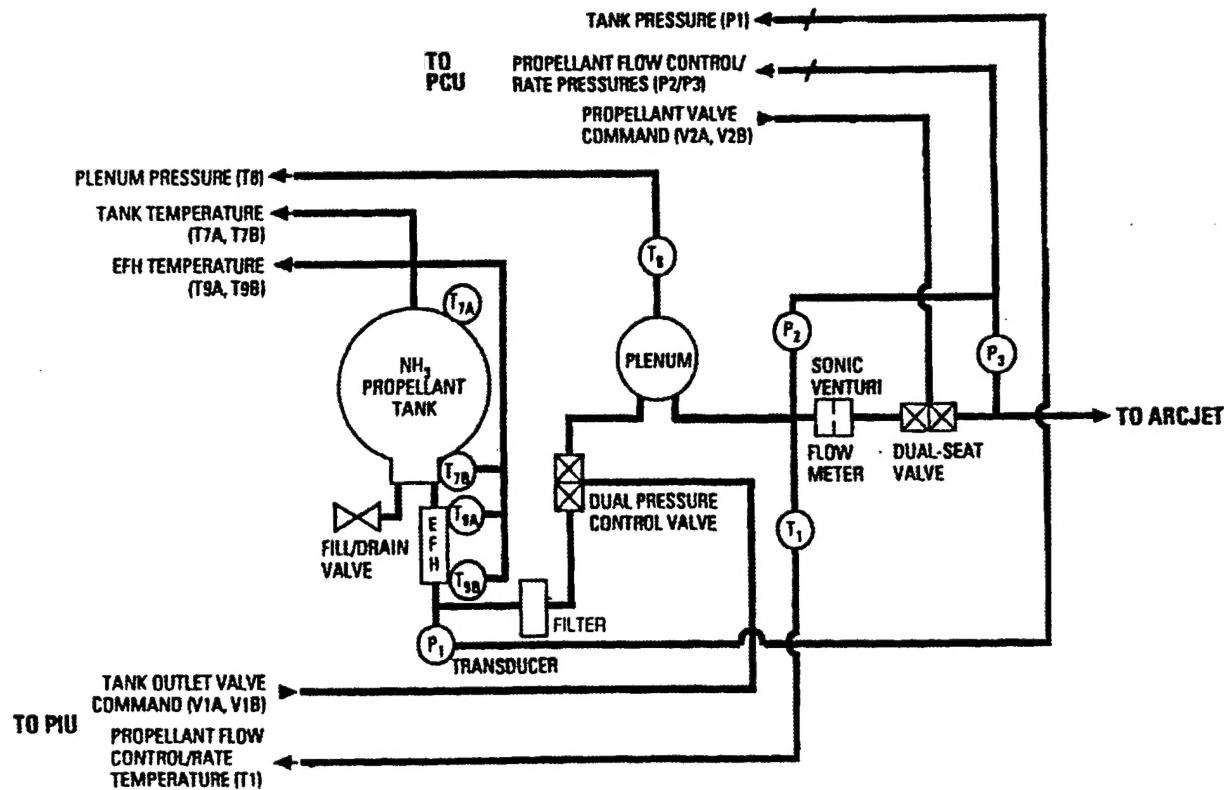
Figure 8 - Schematic representation of the propellant feed system

A schematic representation of the PFS is shown in Figure 8. The operational profile is presented in detail elsewhere^{6,15,16} but basically consists of two heating periods prior to the outflow - one at t-17 hours, and one much closer to the event. This first pre-heat period is to ensure sufficient pressure in the propellant tank to support flow, and the second is to heat the system to ensure the impending outflow to the arcjet is vaporized. The PFS algorithm is started just before the firing and controls the NH₃ flow rate by cycling the dual pressure control (DPC) valve to maintain pressure in the plenum tank corresponding to the specified flow rate.
